RE: Steelcote Facility - St. Louis, Missouri  
Docket No. VII-91-H-0025

**RESULTS OF CONE PENETROMETER  
TESTS AND REVERSE SLUG TESTS  
STEELCOTE FACILITY  
ST. LOUIS, MISSOURI**

**SHANNON & WILSON, INC.**  
GEOTECHNICAL AND ENVIRONMENTAL CONSULTANTS

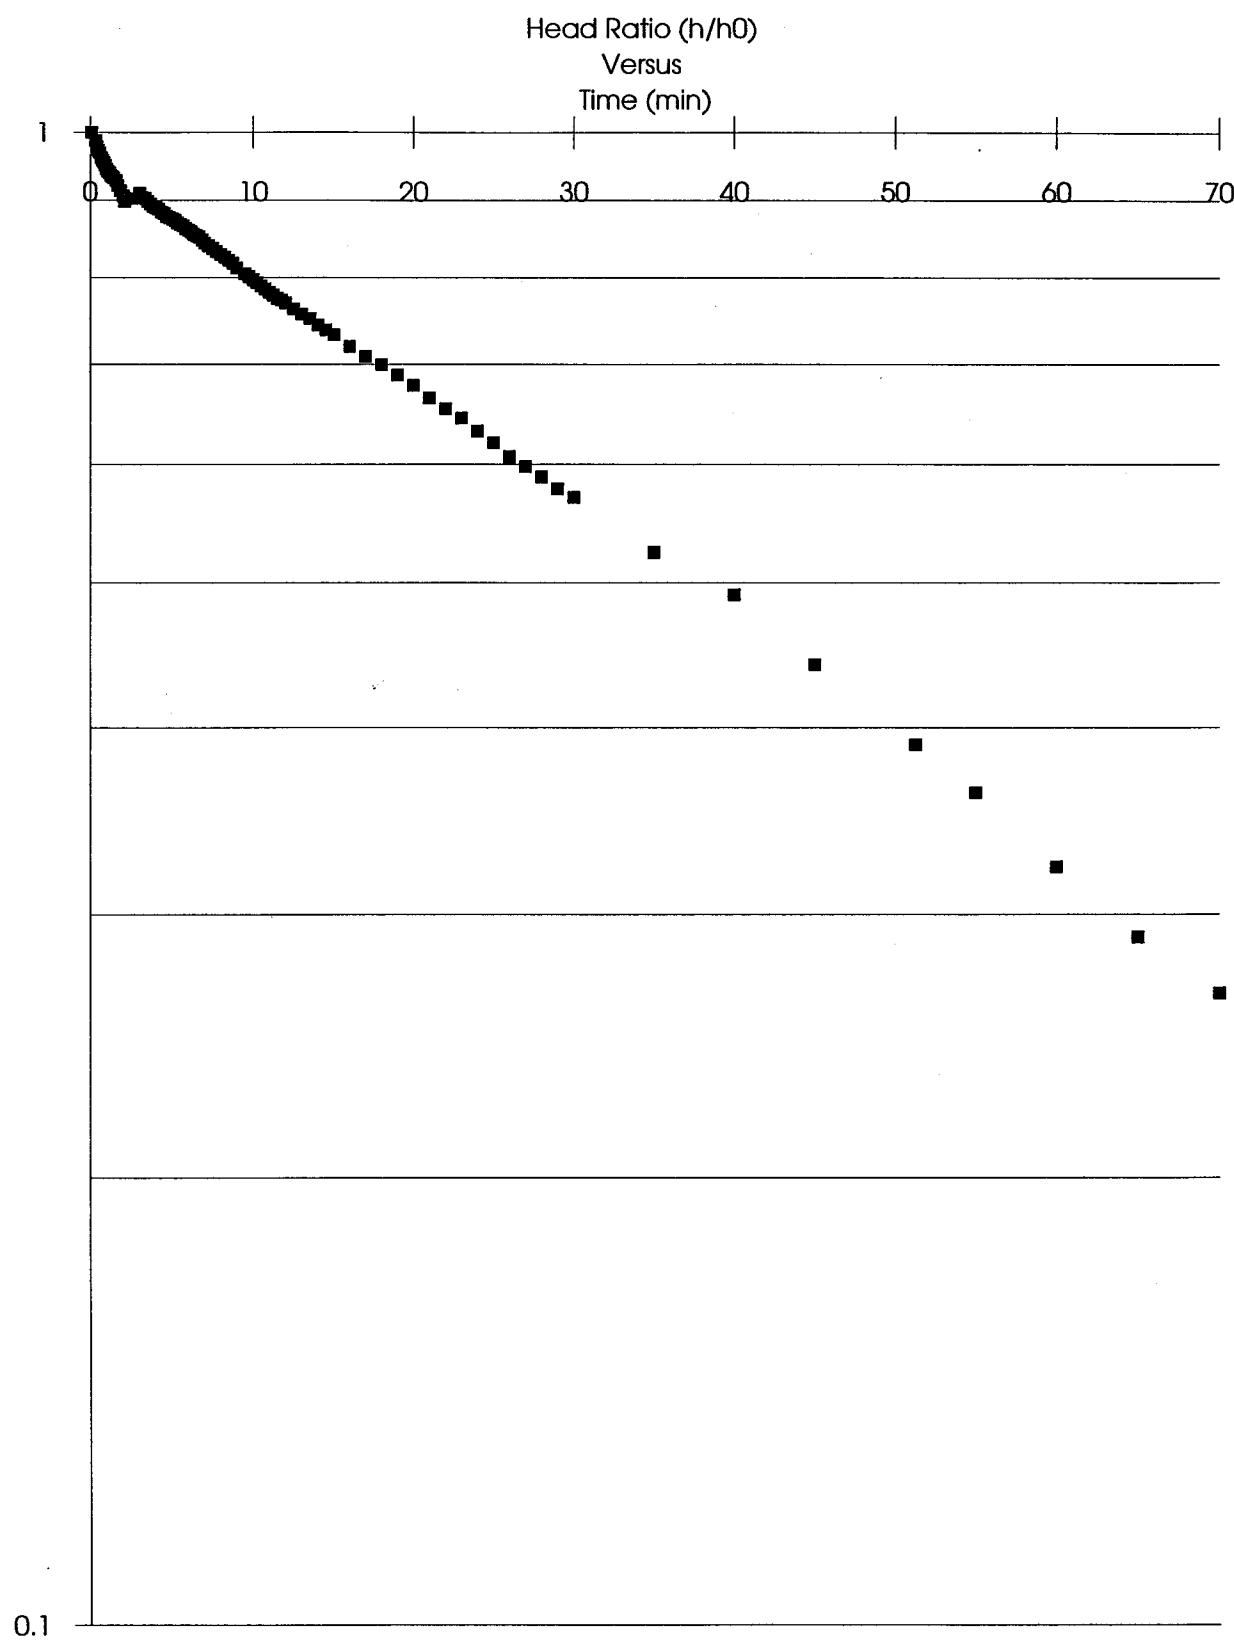
FIGURE C-6

Reverse Slug Test  
Well SWGW/1(B)

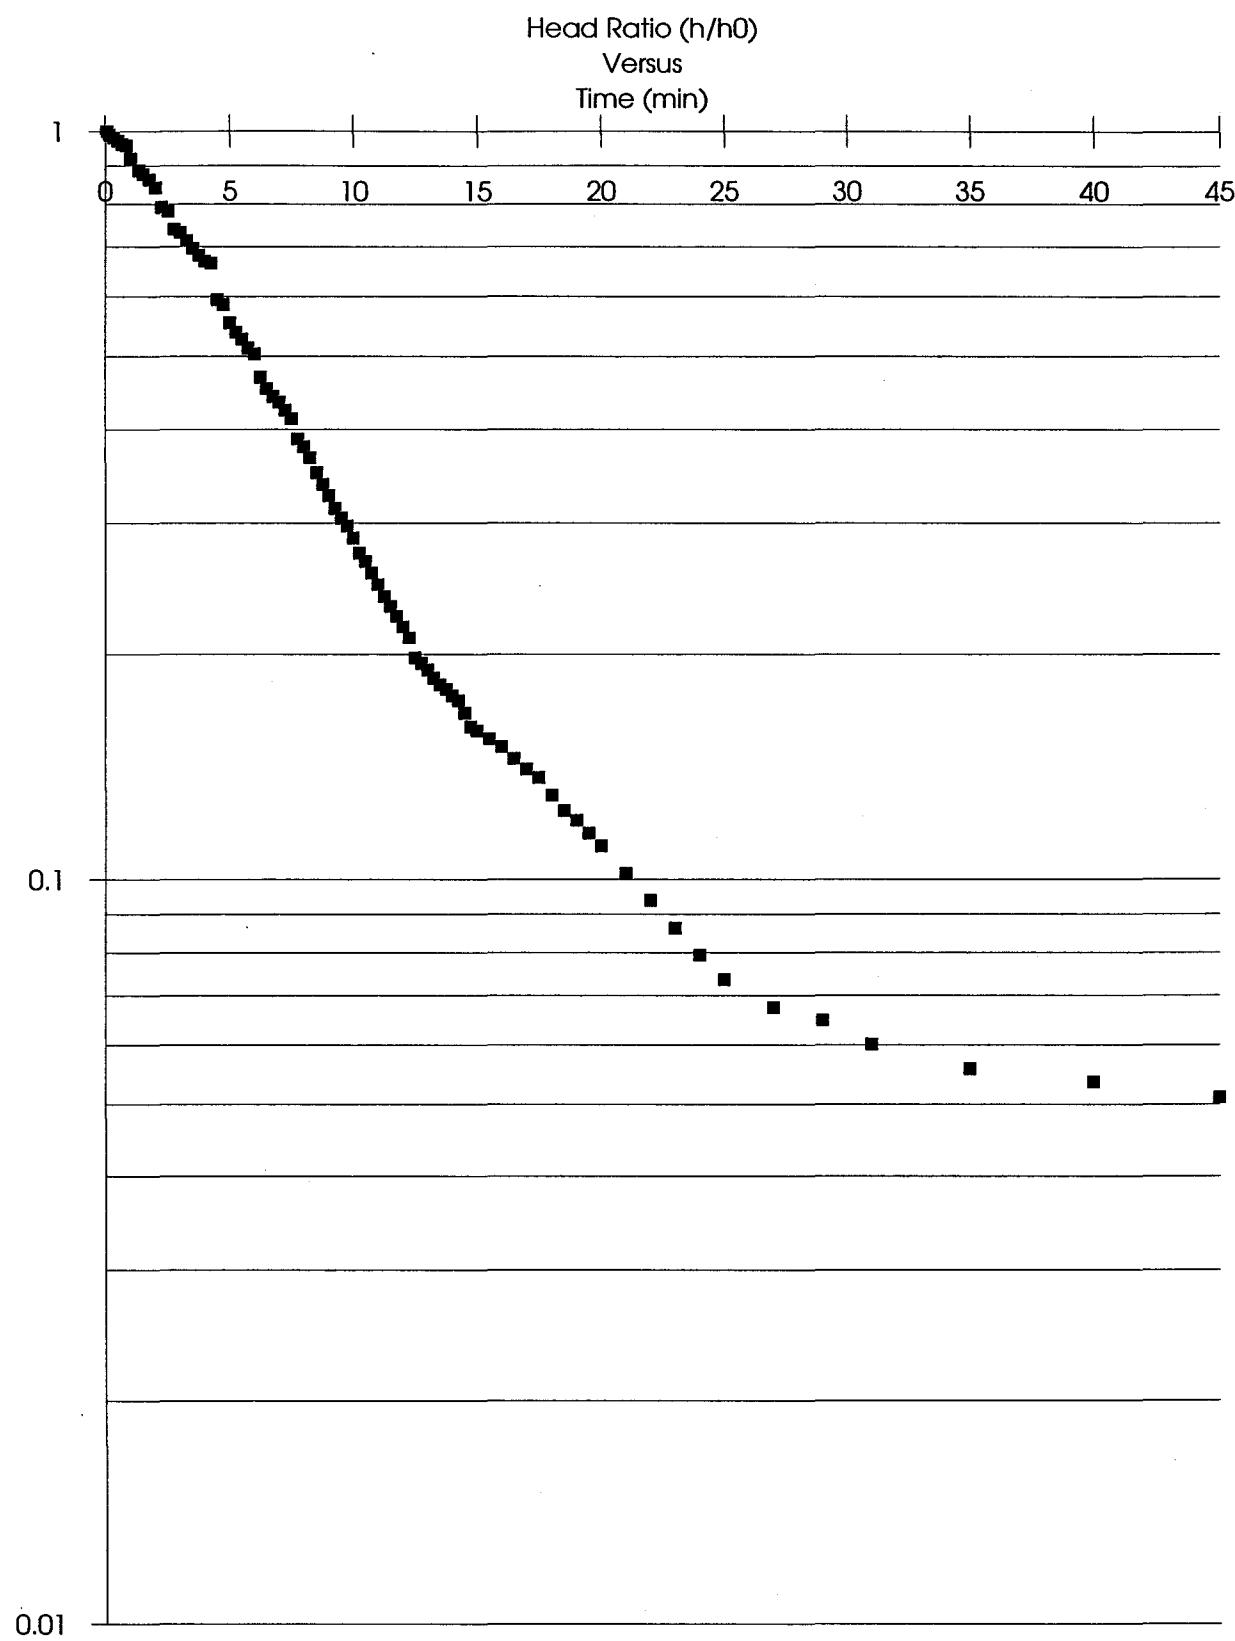
FIGURE C-7

Reverse Slug Test  
Well SWGW/1(C)

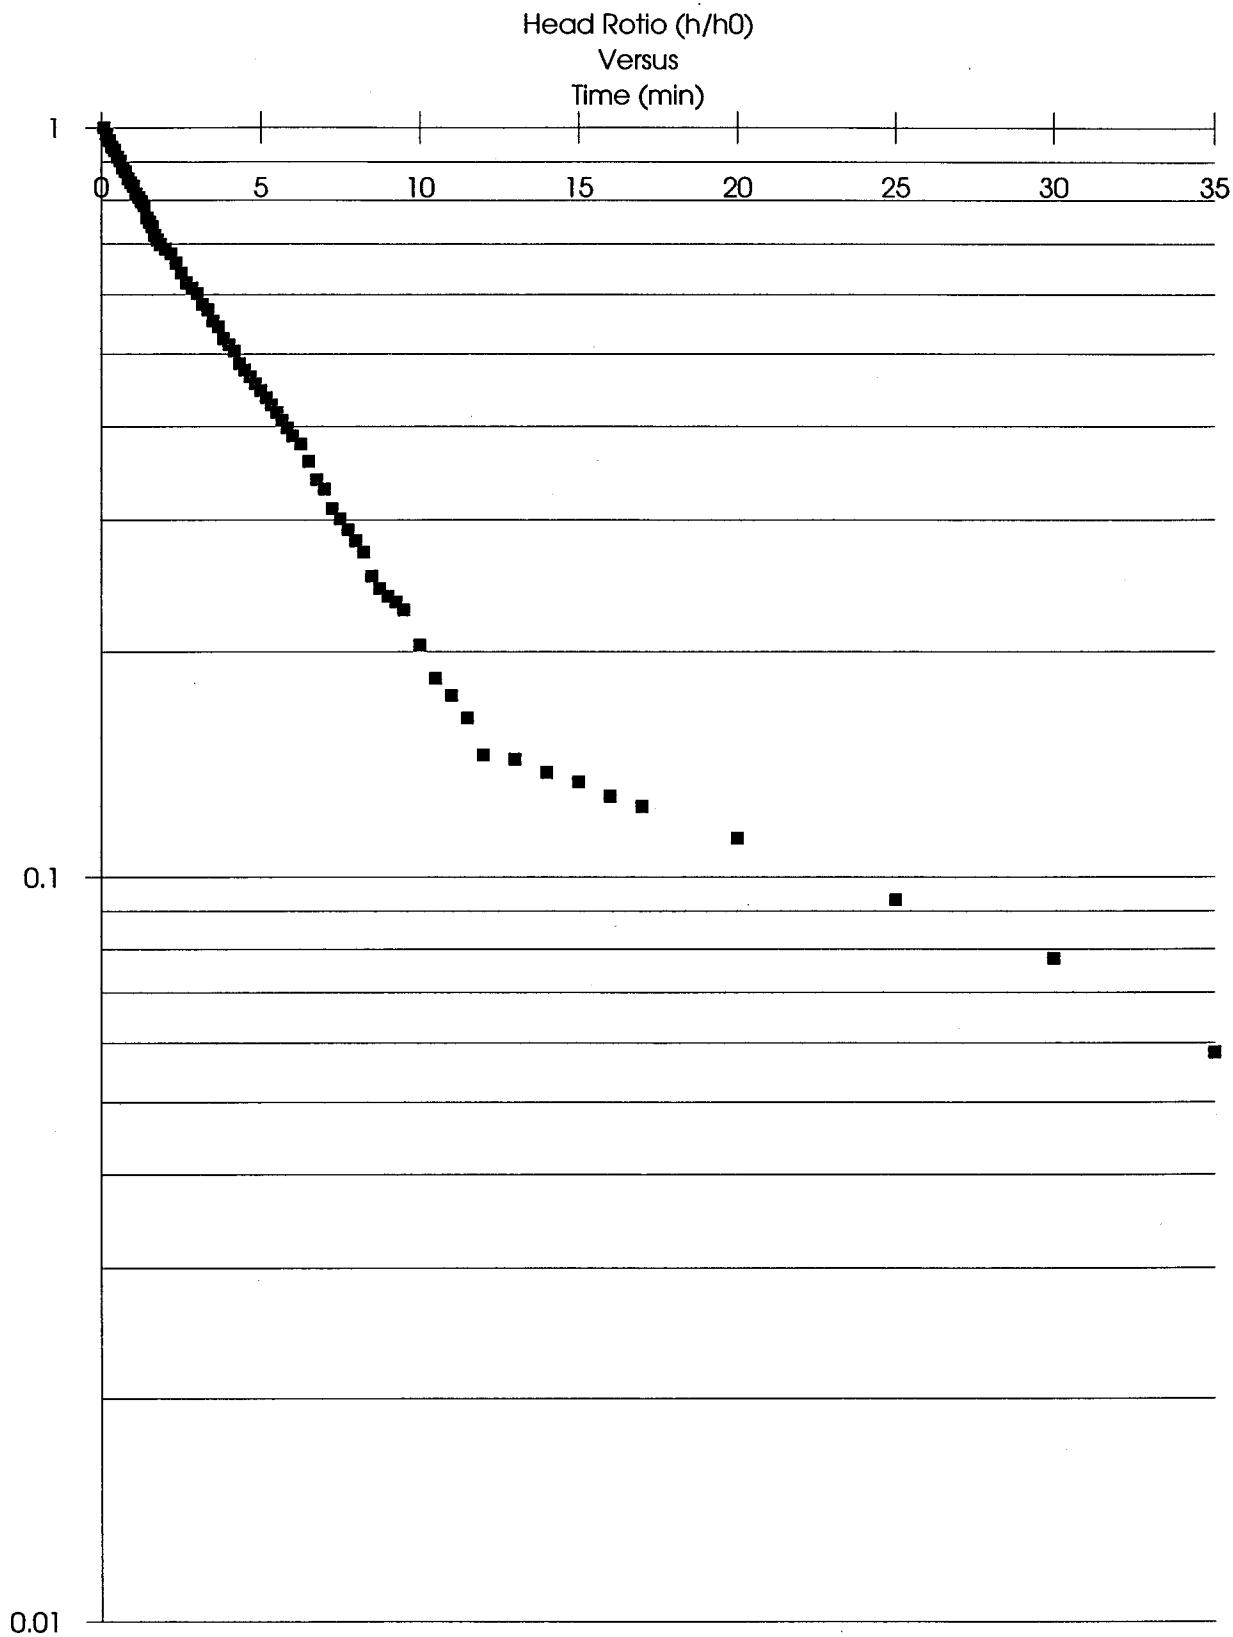
FIGURE C-8

Reverse Slug Test  
Well SWGW/1(D)
